Samish Island Conservation Area Restoration

Feasibility Study and Conceptual Restoration Ideas Report

Blue Coast Engineering LLC, with contributions from
Mott Macdonald
Shannon & Wilson

January 2025

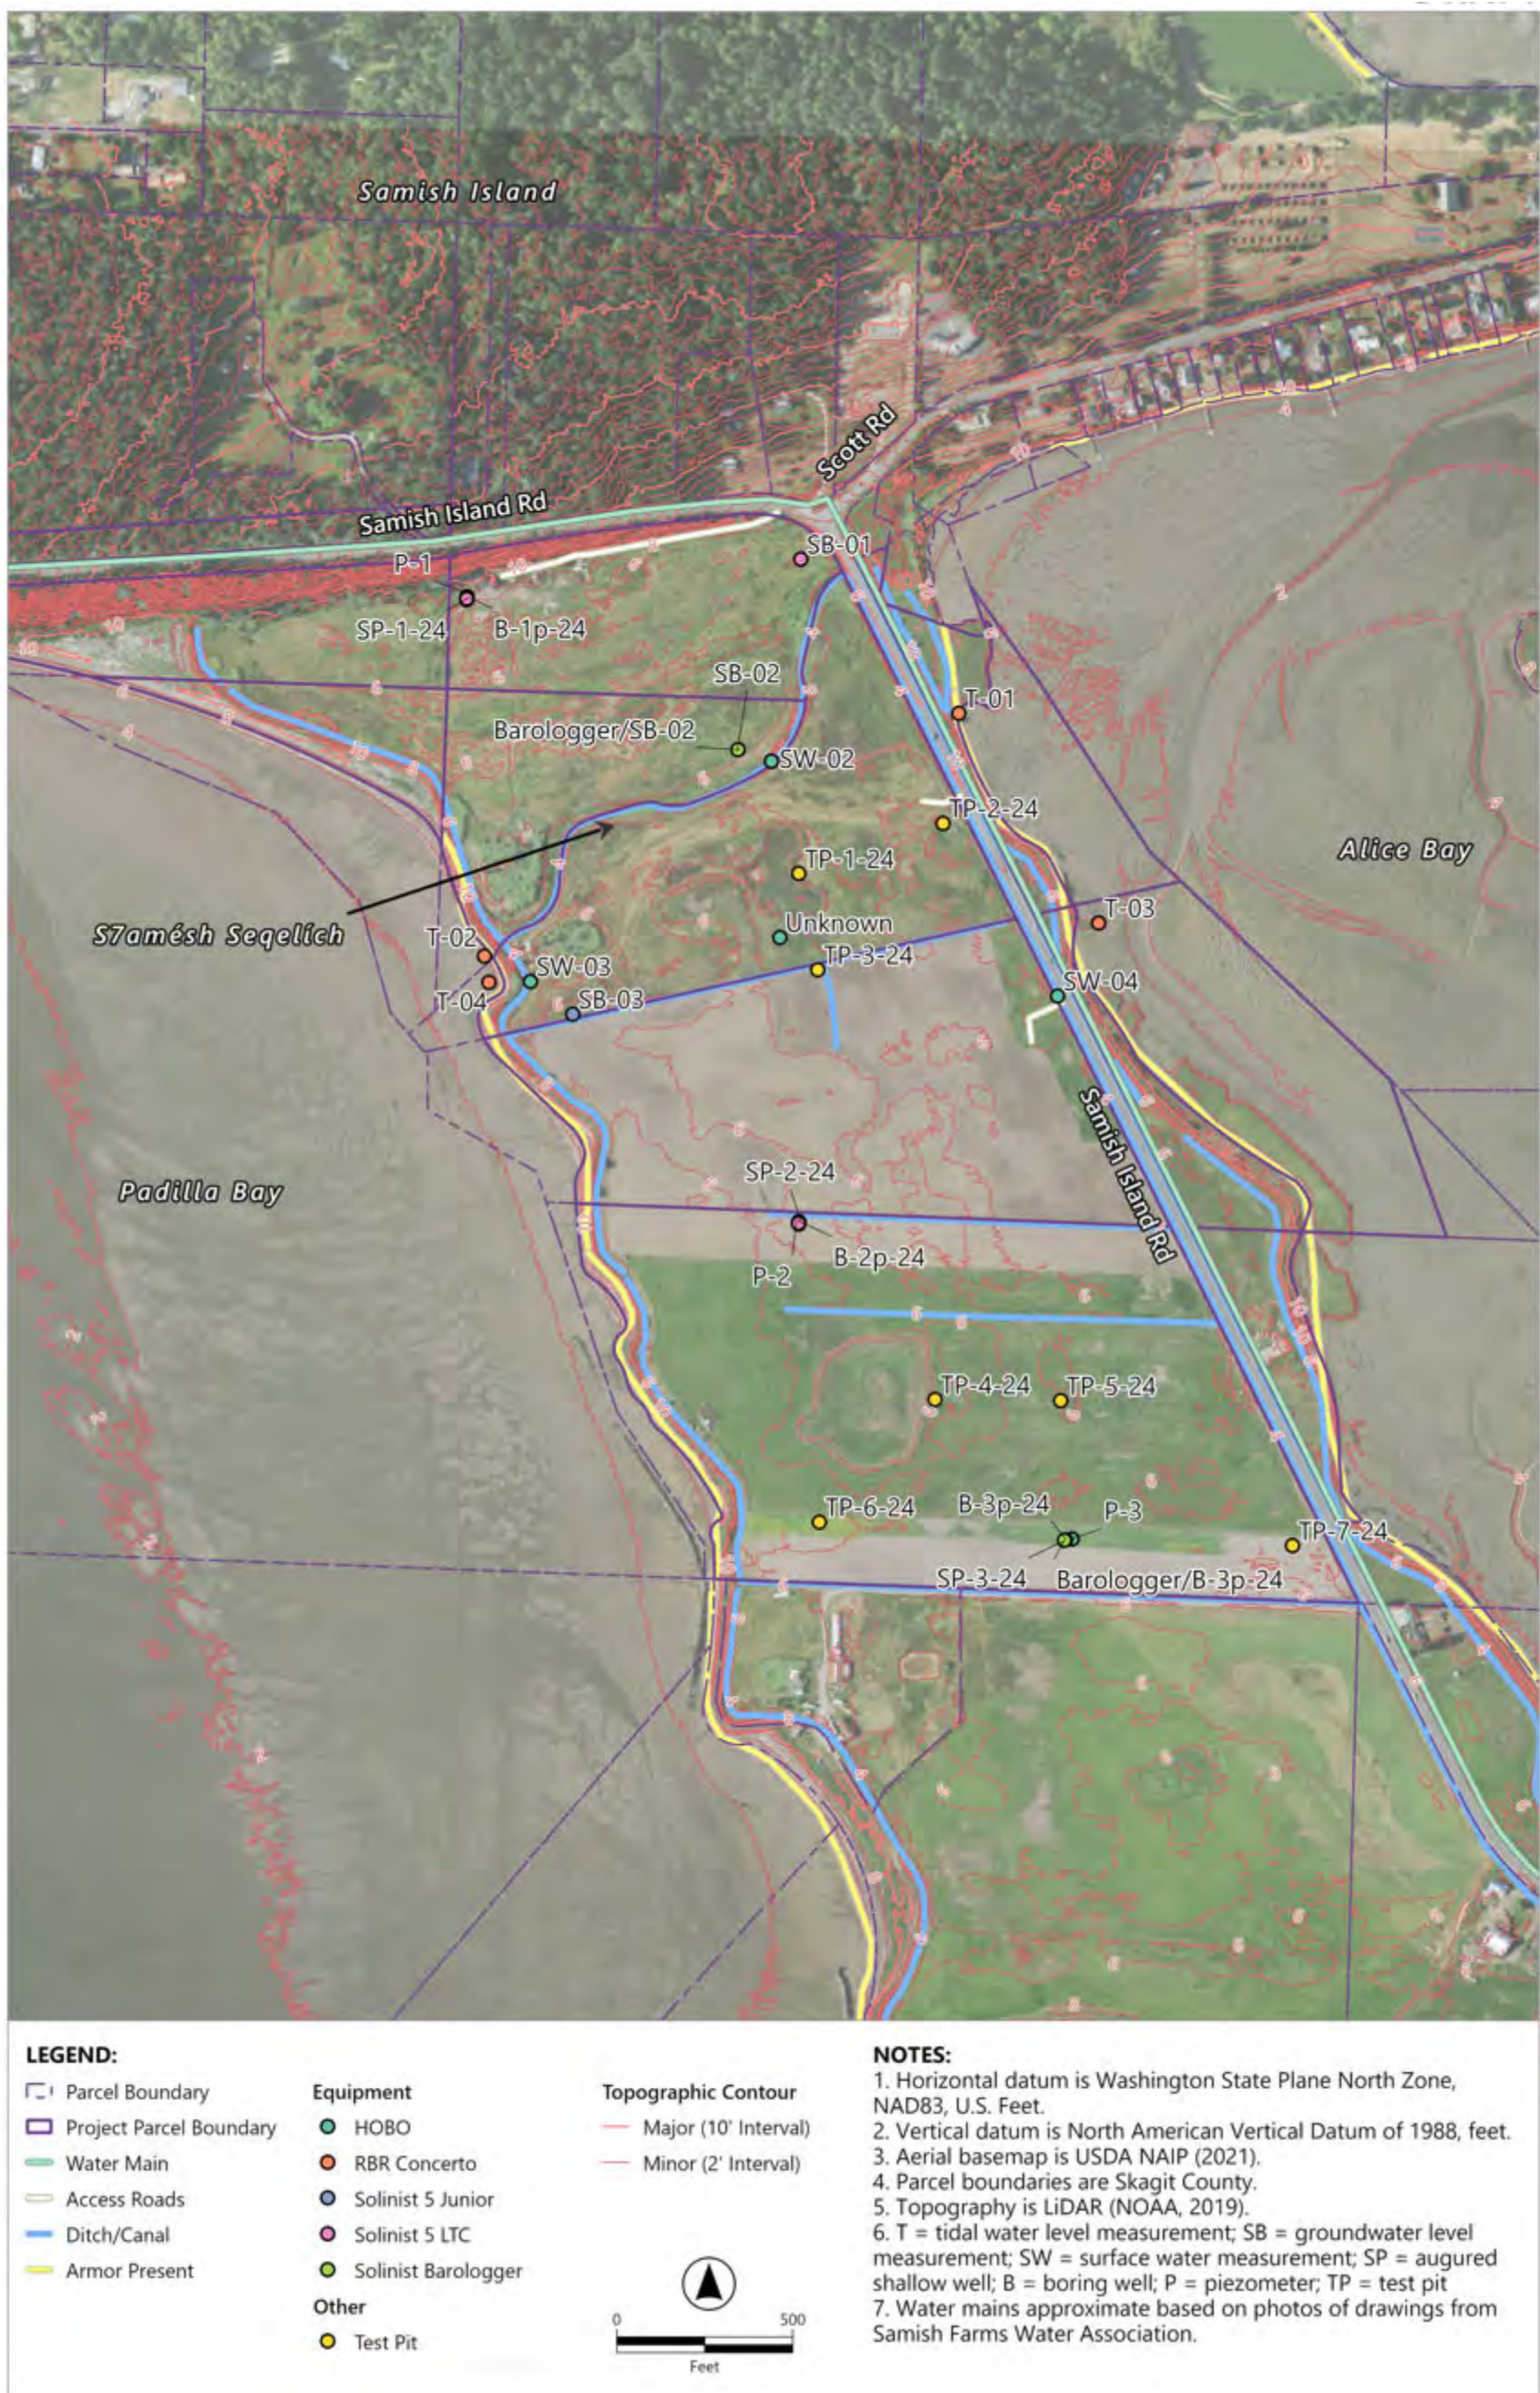
Figure 3. Samish Island Conservation Area data collection site map.

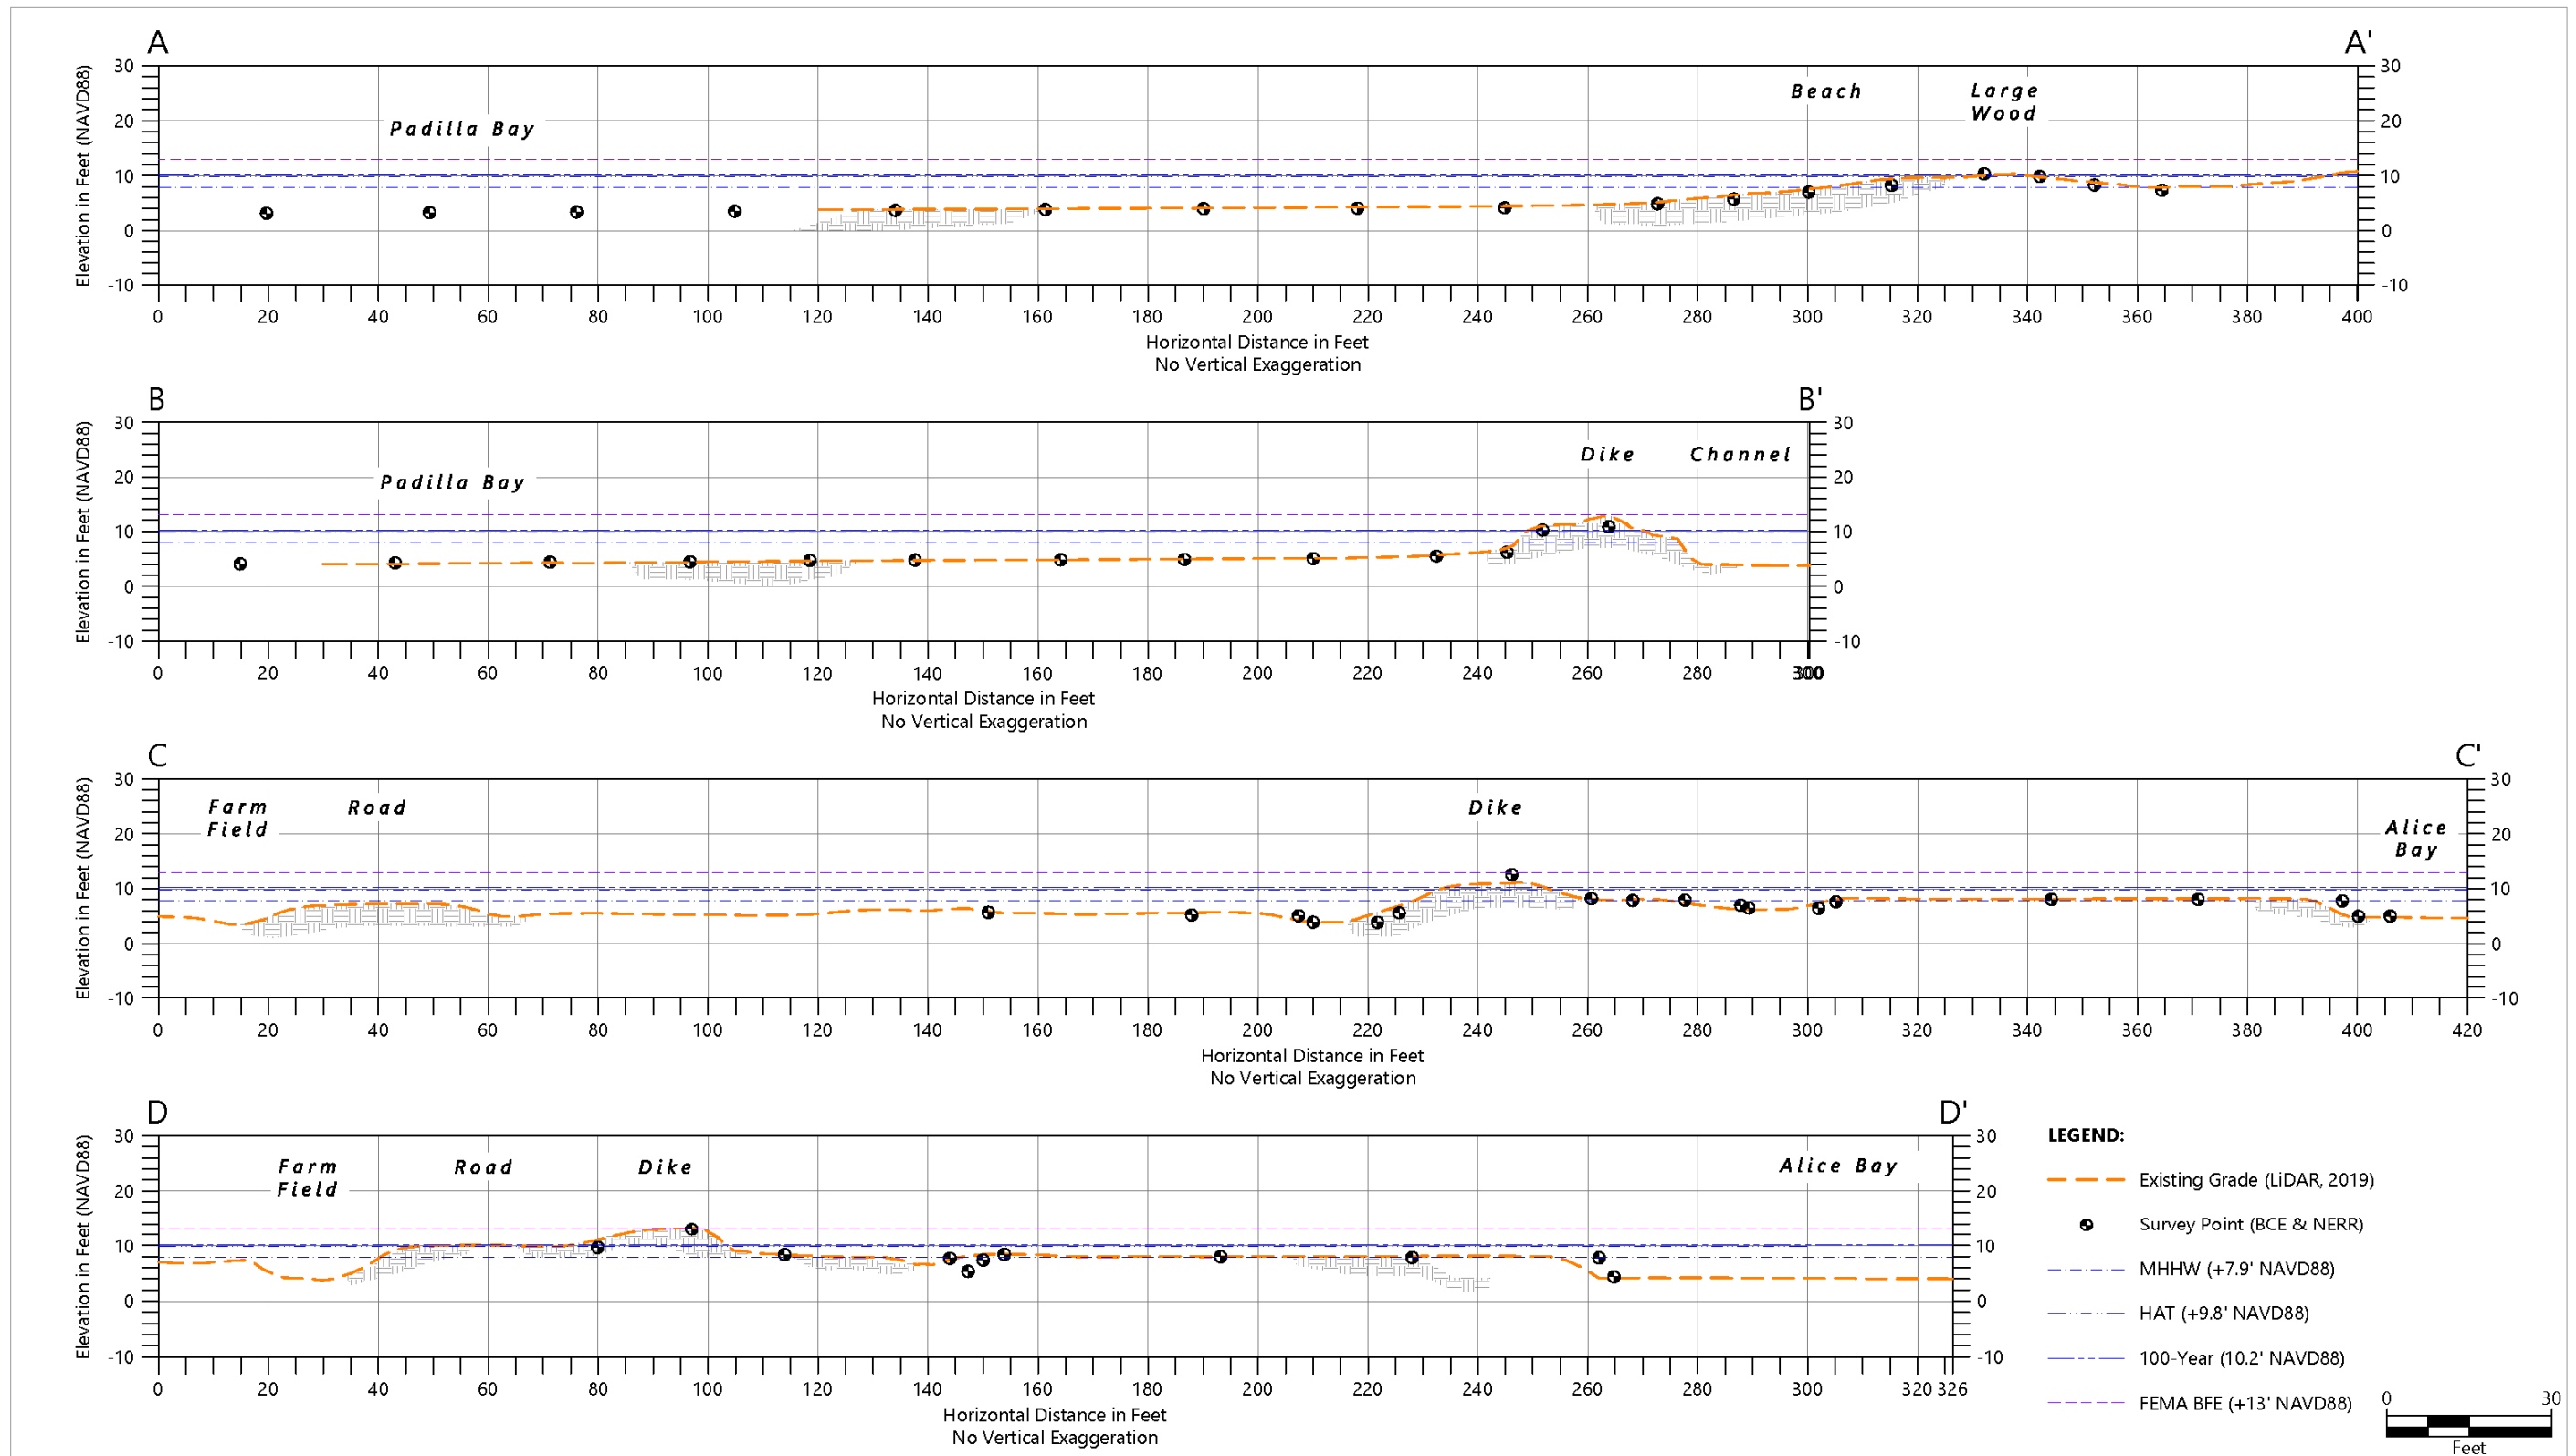
Figure 5. Samish Island Conservation Area topographic profiles. Profile locations are shown on Figure 4.

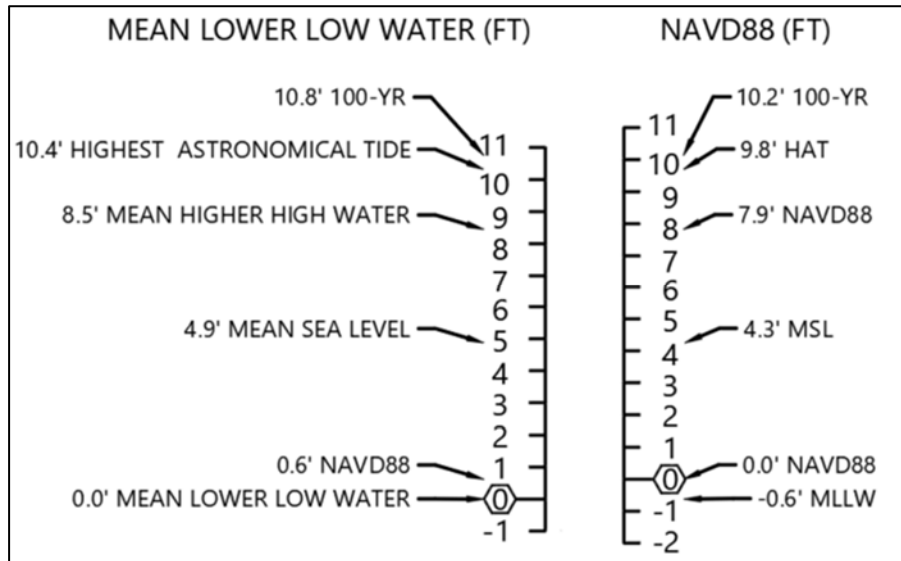
Figure 6. Graphic comparison of water level elevations in tidal (MLLW) and survey (NAVD88) datum at the site.

up, which is calculated in Section 3.2 to provide estimates of total water levels at the site and inform the conceptual restoration ideas. Figure 6 is provided to illustrate a comparison of the water levels in the two datums (tidal and survey).

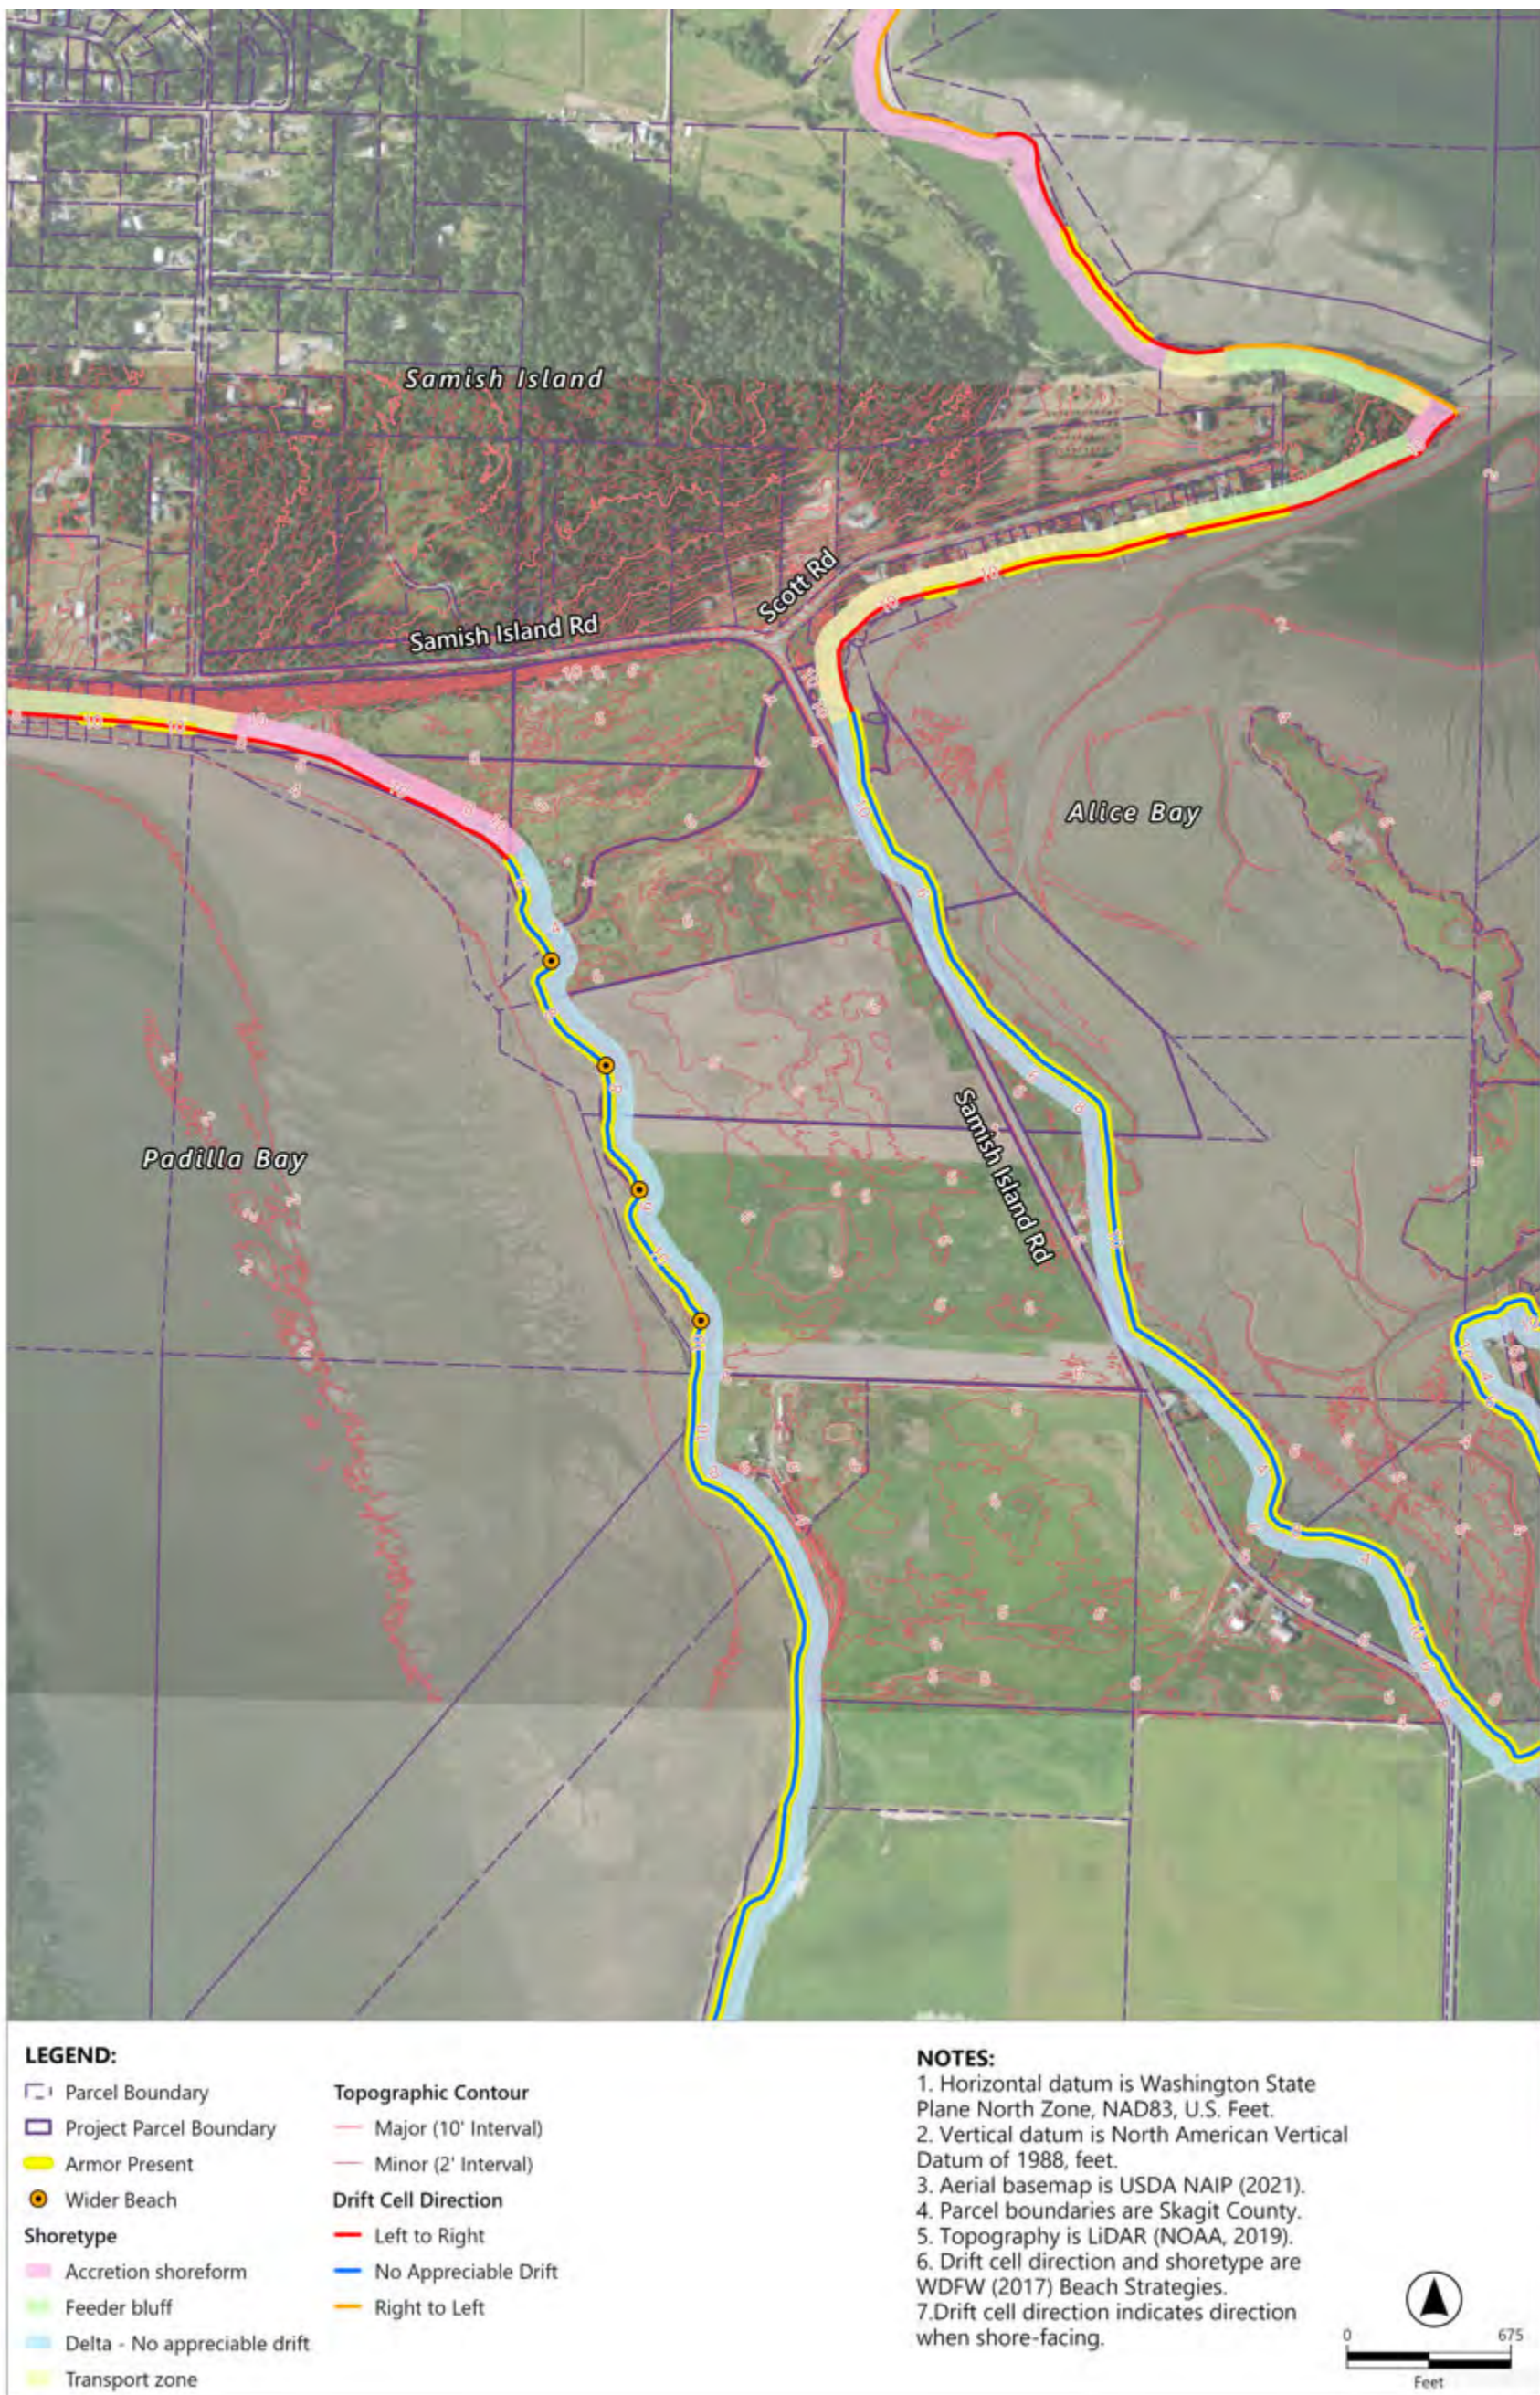
Figure 9. Samish Island coastal geomorphology map.

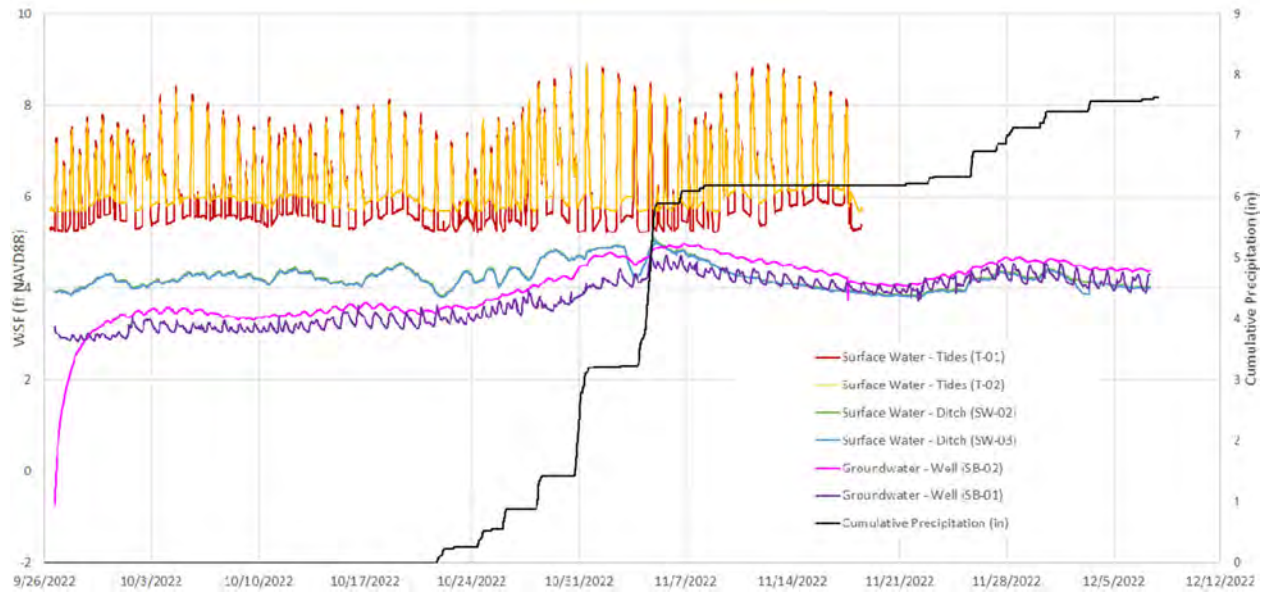
Figure 11. Time series of surface water, groundwater, and precipitation data at the SLT site in 2022.

SLT site water-level monitoring data indicate that ditch water levels have a muted response to daily tidal variations during summer months (Figure 11) and have little to no tidal response following the onset of seasonal rains. Shallow groundwater elevation data from the SLT site exhibit a consistent daily tidal response, and during the late-summer period shallow groundwater elevations are lower than ditch water levels. Following the onset of seasonal rains, groundwater elevations at SB-2 increased and become higher than ditch water level elevations at SW-2. This seasonal change in the relationship between groundwater and surface water elevations suggests that “losing” conditions (where ditch water is lost to groundwater through infiltration) occur during the late summer and “gaining” conditions (where groundwater discharges to the ditch) occur during the winter wet season.
